REPORT ON THE EARTHQUAKE ASSESSMENT IN CHIPINGE

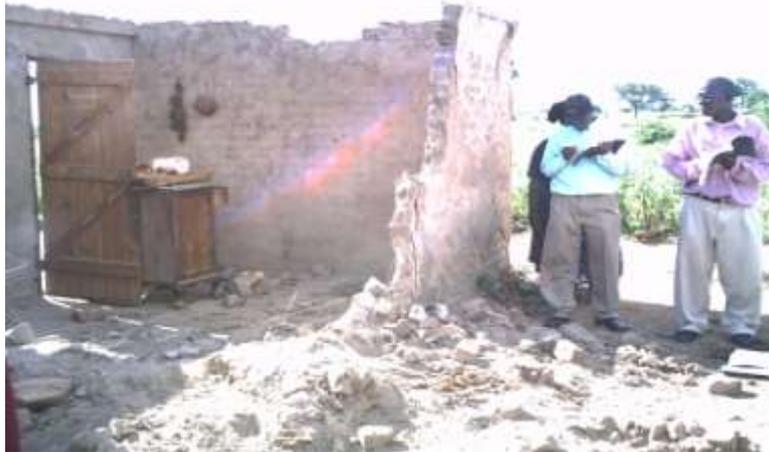
Manzvire Area- House built after 2000 Cyclone Eline Succumbed to the Earthquake

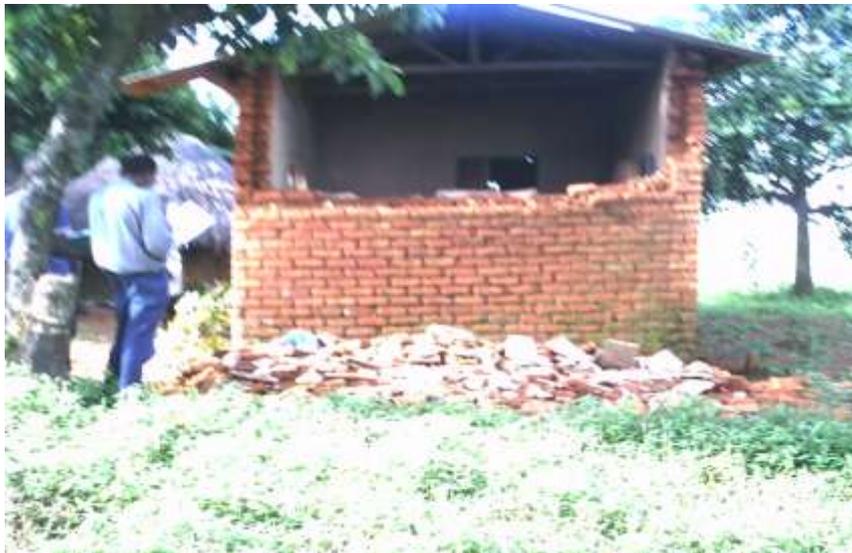
Dimire Village - House Built using Poor Building materials collapsed

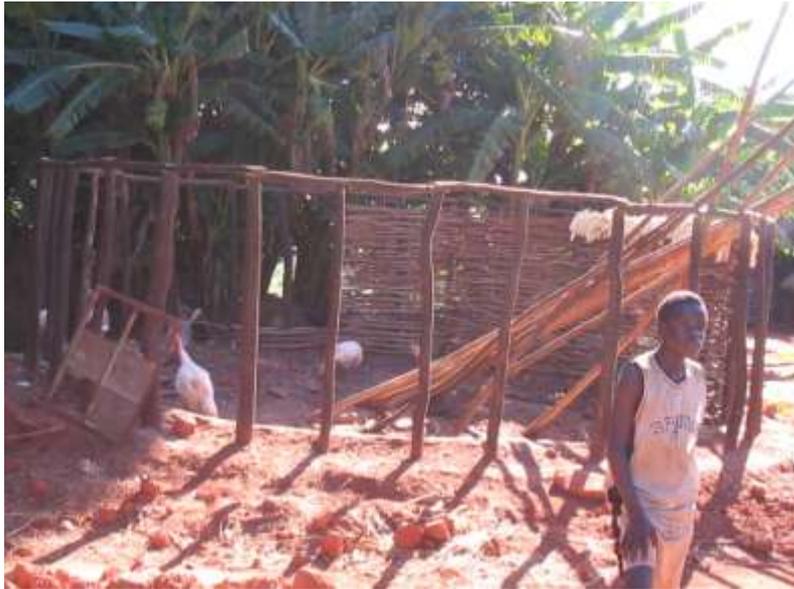
All the visited homesteads in the district can be classified as Vernacular Architecture, which has been adapted to the western rectangular form of Architecture. Sun dried bricks (adobe) were used and this was done without proper reinforcement such that the houses were vulnerable to collapse when the earthquake struck. Three such structures succumbed to the shaking with east facing walls collapsing. A rare case was Mrs S Mhlanga's round hut that collapsed trapping five occupants and injuring one.

Mrs Mhlanga's hut that caved in: now under reconstruction

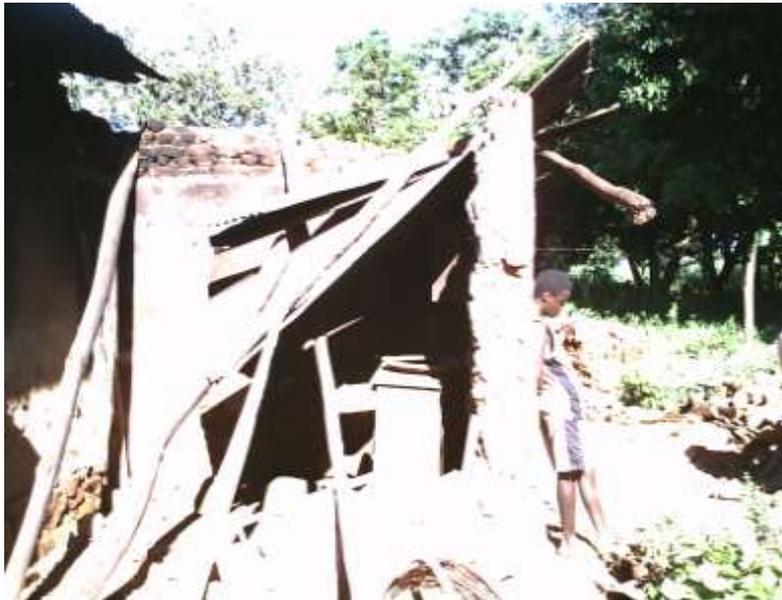
Dimire Area- house collapsed

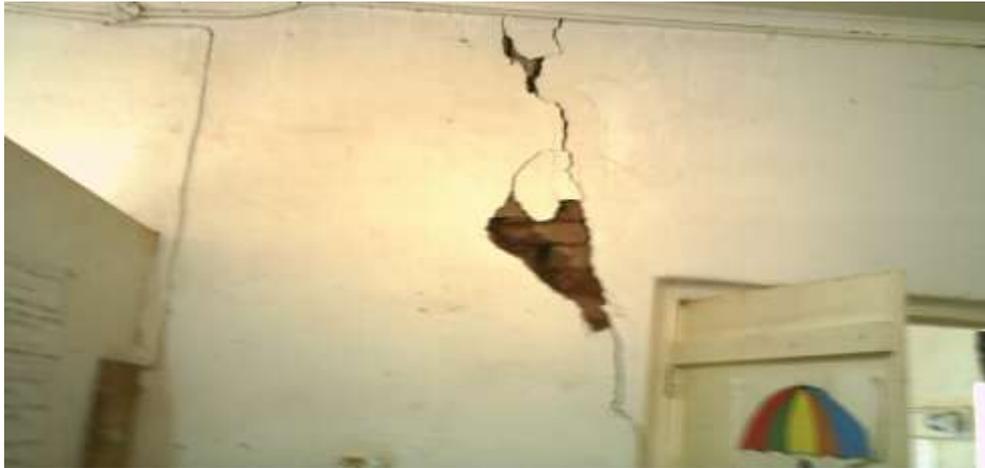
It is believed that the clinic was built in the early fifties as a farmhouse and was later turned into a Clinic in 1980. Due to its advanced age, vertical cracks had developed on the walls and these were exacerbated by the earthquake. The cracks widened to widths of 10mm at some parts and these were observed in the reception area, treatment room and veranda.

Chiriga Clinic - Cracks at the Reception Area

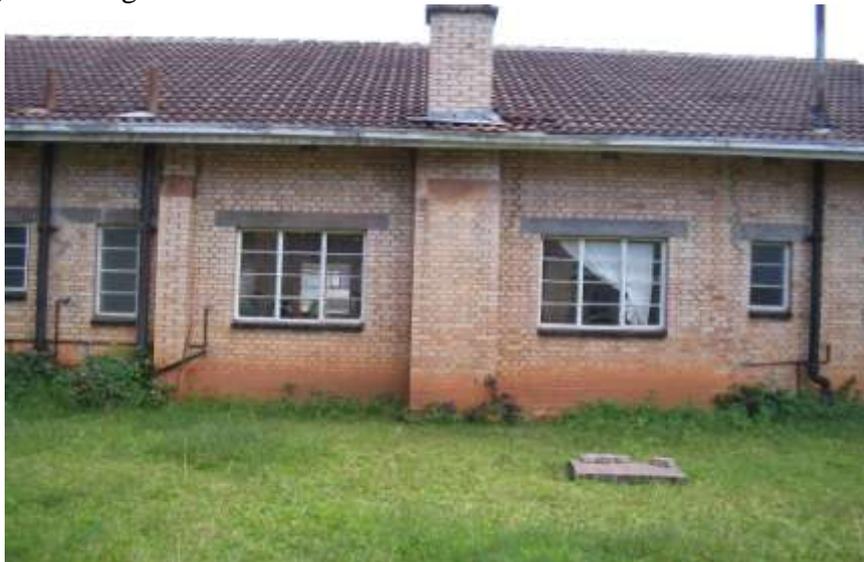
The hospital was established in the 1890s. Though old and close to the epicentre, the firm structure are founded on bedrock and stood the effects of the quake but most windowpanes were shattered. The main Hospital building had minor faults apart from a few shattered windowpanes and a concrete chimney lid to one of the wards dislodged to the ground. Interior cracks on some staff houses were also observed.

Chimney lid weighing almost 100kgs was dislodged to the ground

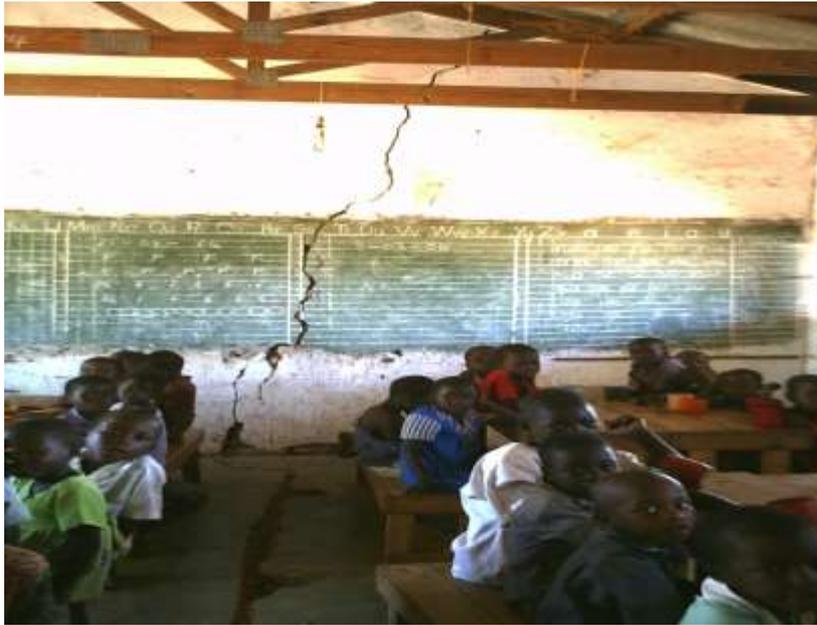
Mwacheta Primary School

The traditional form of school classroom block is the rectangle and all schools visited comprise of this basic architectural form which all display similar characteristics in terms of consequent to the effects of the quake. Irrespective of the materials used and method of construction, farm or cement blocks, sand cement or clay mortar, vertical cracks developed on the interior and exterior walls with internal junctions of walls being the most severely affected. Areas also affected in some classroom blocks include window and door lintels with the most severely affected being those made of unreinforced brickwork.

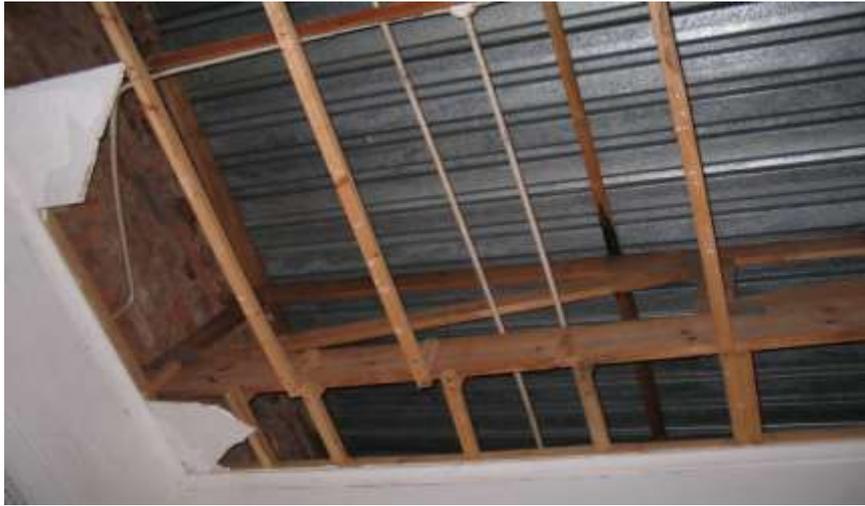
At Chikore High Mission the double story upper floors were most severely affected as some portions of plasterboard ceilings collapsed. This was mainly due to inappropriate fastening of the battens to the saw timber bearers resulting in non-structural integrity with the rest of the structure.

Chikore Mission: plastered ceiling collapsed

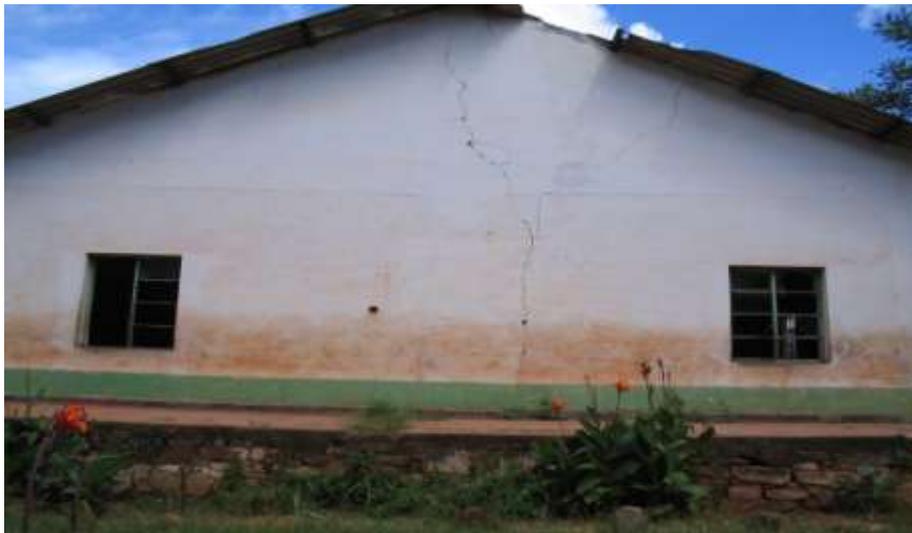
A Class Room Block at Mahenye Primary School

At Mahenye Primary School, the eastern wall of a block of classroom has cracks separating wall from the floor, wall from the slab (horizontal) and two vertical ones detaching the wall from the rest of the building.

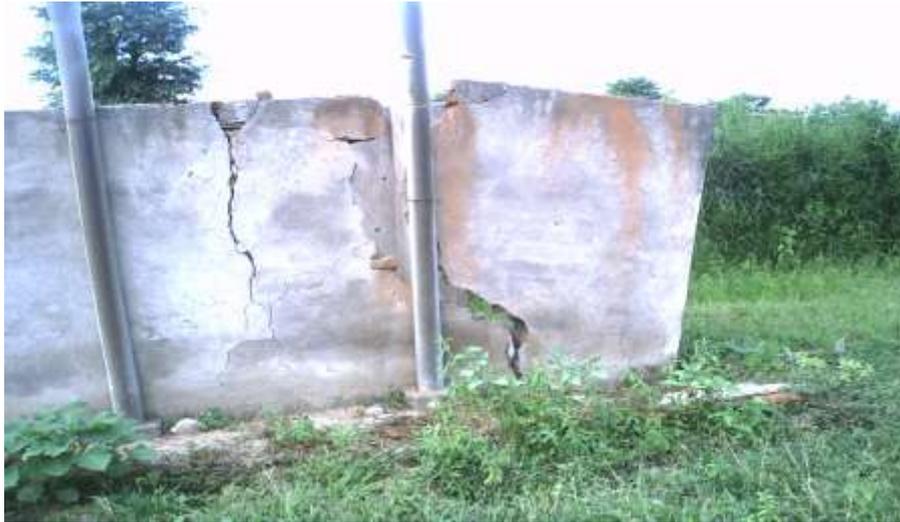
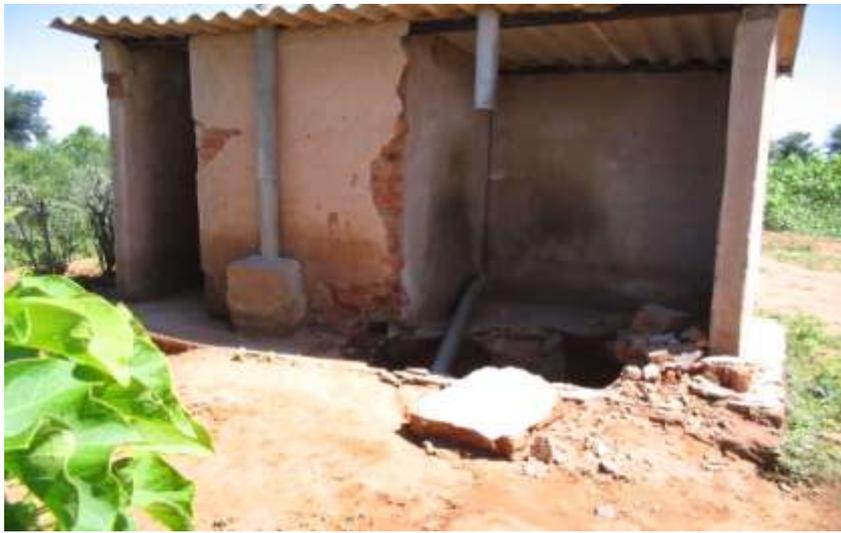
The effects of the earthquake to Blair toilet are a cause of worry as these were the most severely affected with some of them totally collapsing. At Muzite Primary School and Mahenye clinic, the slabs and walls to Blair toilets had deep cracks splitting the slabs into two halves rendering them unsafe for use. Vertical cracks also developed on the walls. At Mwacheta School, the toilet completely collapsed. It was observed that the slab to some of these had no mesh reinforcement that would have prevented the slab unit from disintegrating.

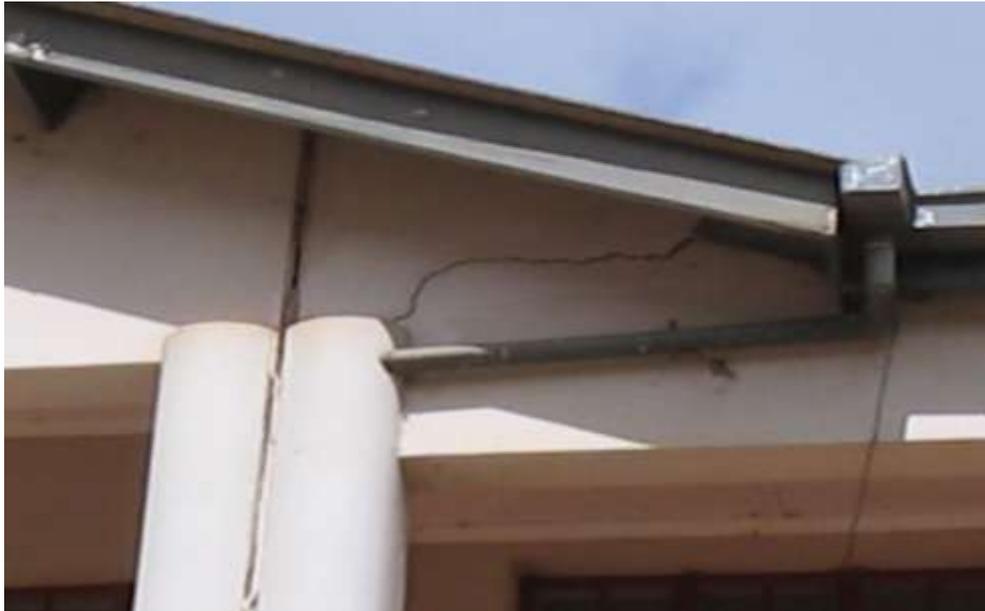
Effects of the earth earthquake were also observed on modern structures/ houses built with sound construction principles though the cracks were minor as compared to those built earlier.

The Chipinge government complex was not spared

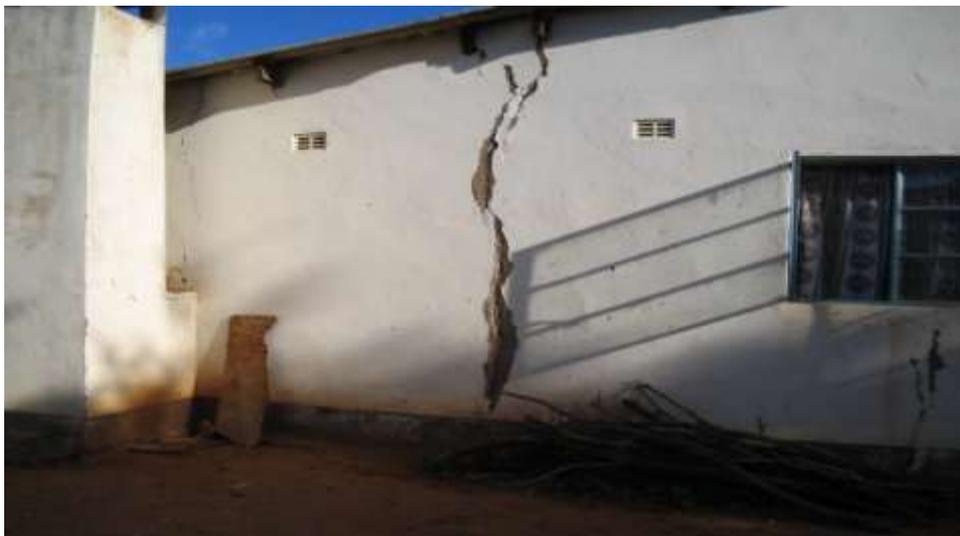
Muzite Primary School : Modern Teacher's House also Succumb to the Earthquake
